Introduction to Map 13: Rubha nan Earachan to Fionn-phort

This map section covers some 3.8km of coastline. It comprises of undulating but generally low-lying ground within the coastal zone. Much of the coastline is rocky and parts are overgrown with boggy scrub woodland. In the south of this section, the hinterland rises up to form the flanks of Beinn Dubh, the summit of which stands 267m OD. The coast edge in this map section has been classified as stable. Much of the hinterland is composed of moor and rough grazing, with some wooded areas centred on Baleachdrach. There are no modern settlements, roads or tracks within this section and access to the coast is by foot.

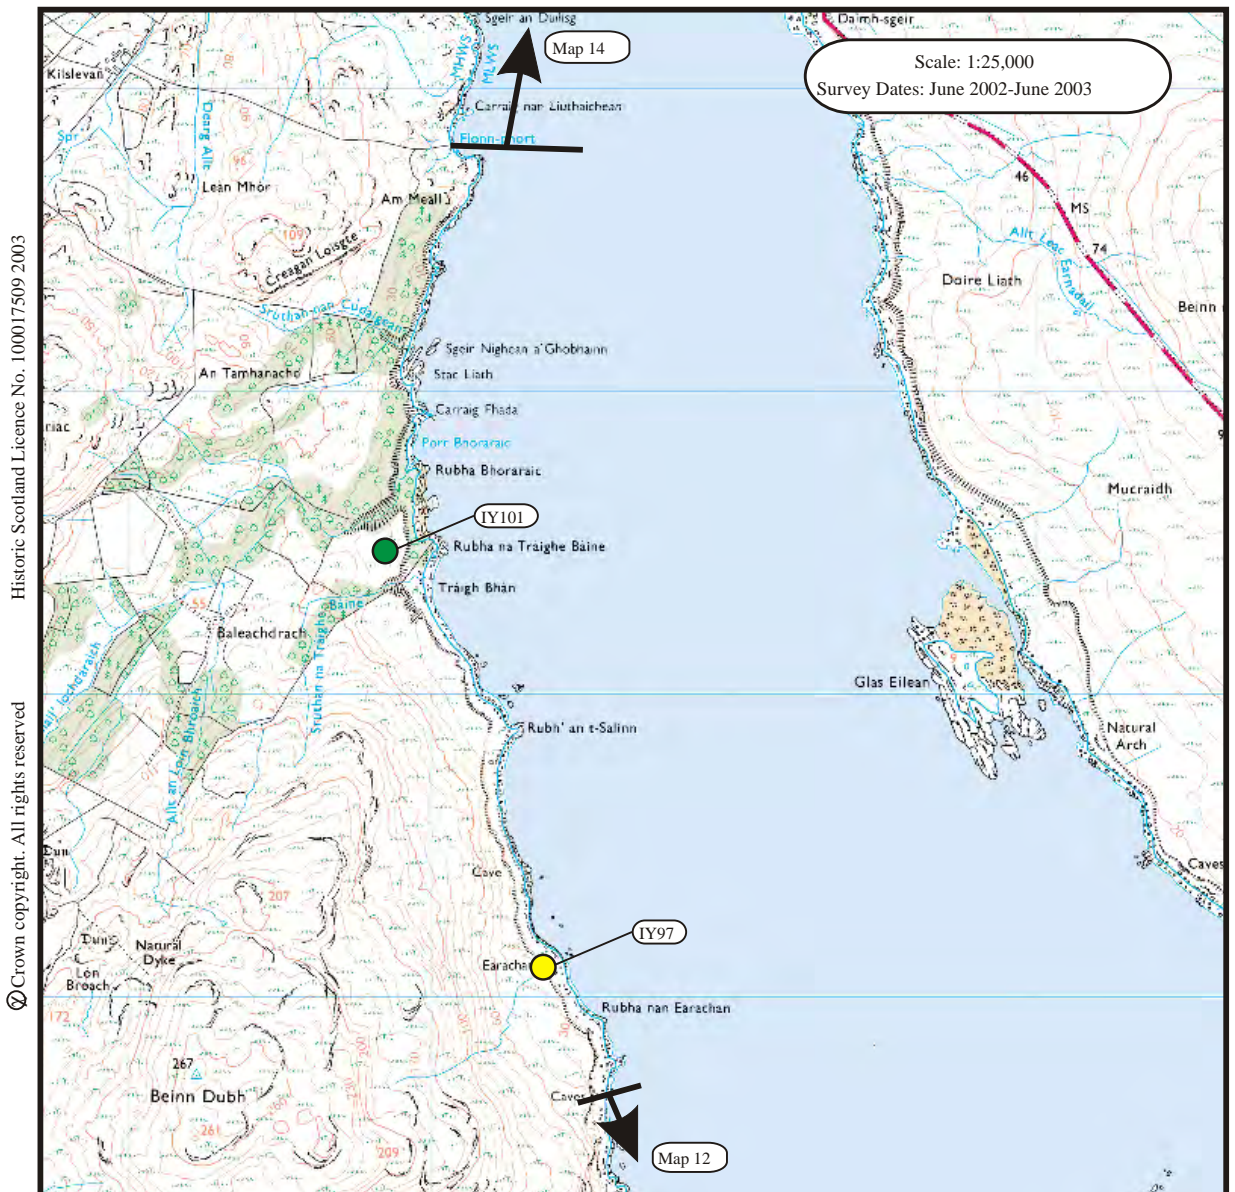
A total of two sites were identified within this map section; one of these had been recorded previously. Both sites are of 18th-20th C date and comprise of cultivation remains (IY101) and structural remains (IY97).

IY97 (NR46SW 23)

NR 43420 64091

Earachan

Structural remains- house ?

IY101

NR 42862 65498

Rubha na Traighe Baine

Cultivation remains

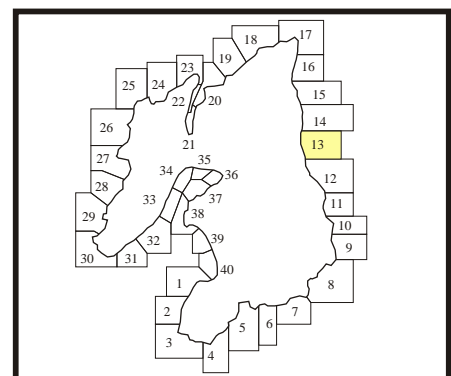
1. Baleachdrach

Rock platform

Coast edge <5m

Drift on visible rock/ Raised beach etc.

The coast edge is covered by cobbles, broken by rock outcrop and loose boulders. The coast is divided into a series of wide shallow bays. There are low cliffs set back from the coast edge on the northern part of this unit.

The low lying land between the cliffs and the sea is interpreted as raised beach. The hinterland is rough and overgrown with frequent patches of scrub and bracken.

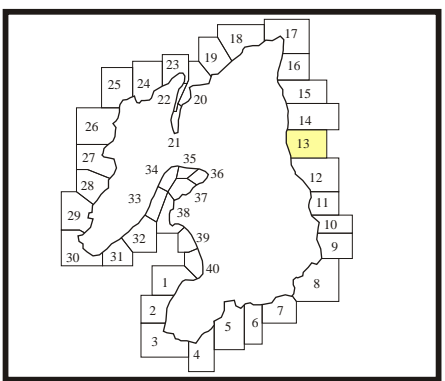
1. Baleachdrach

Stable

The coast edge in this unit is rocky and stable. No signs of erosion.
