Introduction to Map 26: Eilean Mhor to Campa

This map section covers some 8.5km of coastline. This west facing section of coastline is rugged and although generally low-lying (10m or less OD), there are high cliffs surrounding Dun Bheolain and Dun na Nighean, to the centre of the area. The coast edge in this map section has been classified as stable. At the southern end of the section, there are sandy beaches at Traigh Fleisgein Bheag and Traigh Fleisgein Mhor. The hinterland is composed of largely unenclosed moorland and rough grazing. Modern settlement in the area is sparse and lies outwith the coastal zone. There are no modern roads or tracks providing access to the coast until Saligo, at the southern end of the area.

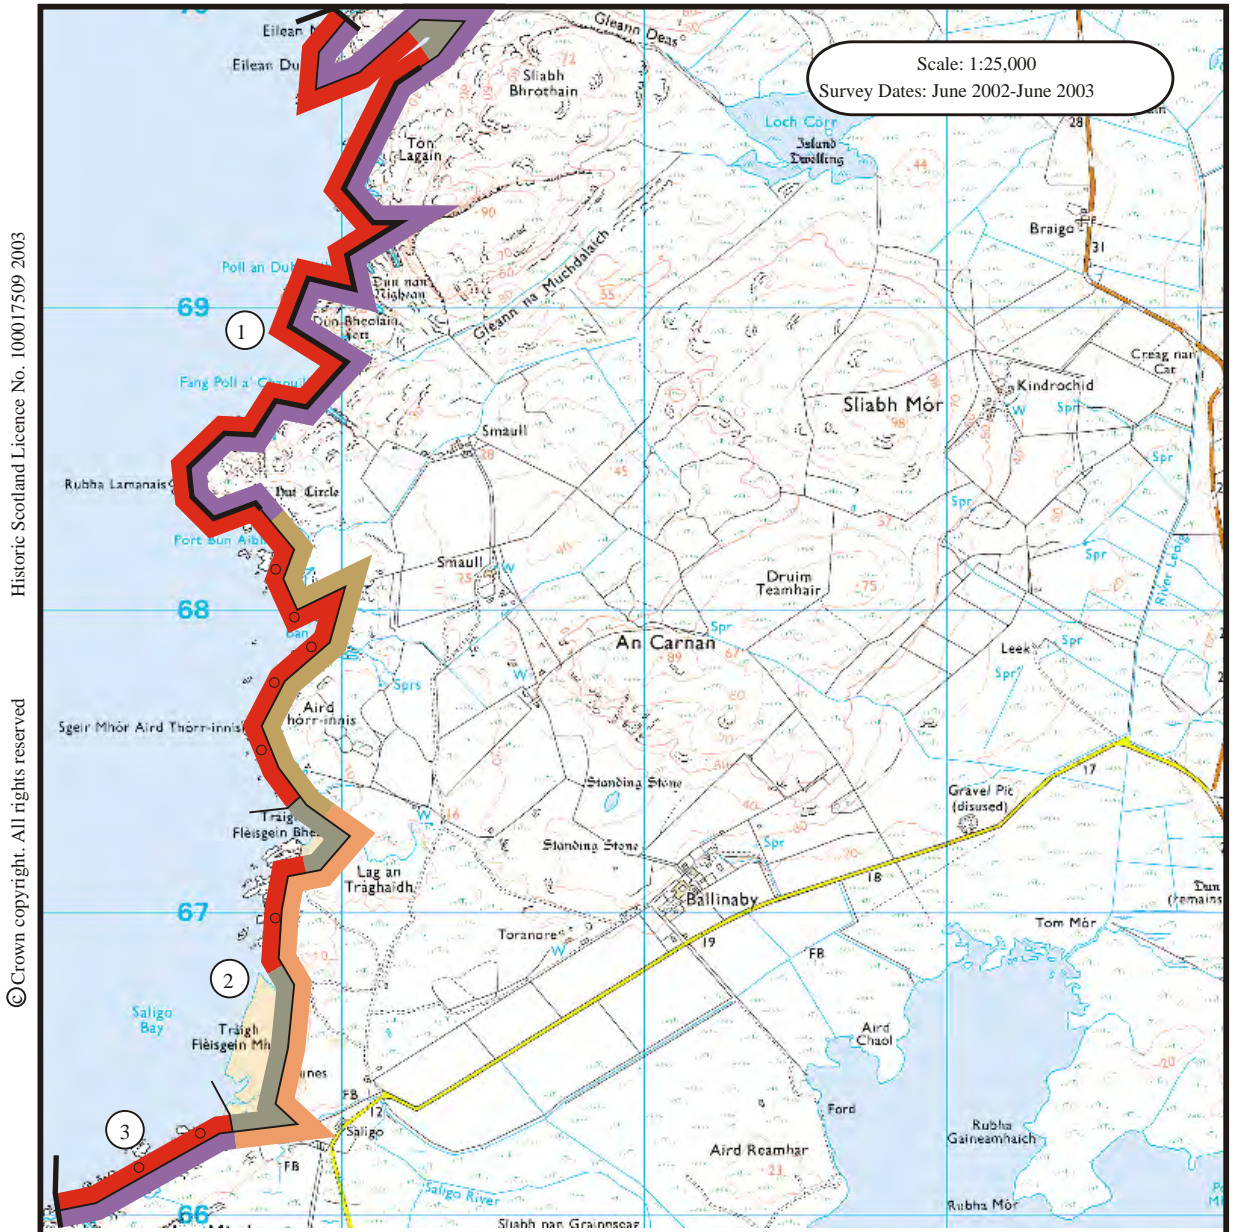
1. Smaull

Rock platform

Coast edge mostly >5m

Drift on visible rock/ Raised beach etc.

This unit has a rocky coastline which rises over 5m in height to the north of Port Bun Aibhne. In many areas there is no vegetation for a distance of 30m - 40m from the coast edge. There is a small sandy beach at the head of an inlet at the north end. The hinterland is poorly drained rough grazing, broken by rock outcrops. There is raised beach in a narrow strip to the south of Port Bun Aibhne.

2. Traigh Fleisgein Mhor

Rock platform/mainly sand

Coast edge <5m

Blown sand.

This unit encompasses two sandy beaches separated by a small rocky promontory. The hinterland is dunes, except by the promontory where it is poorly drained rough grazing.

3. Saligo

Coast edge < 5m

Drift on visible rock.

Rocky coast edge with cobble cover in coves. The hinterland is poorly drained rough grazing.

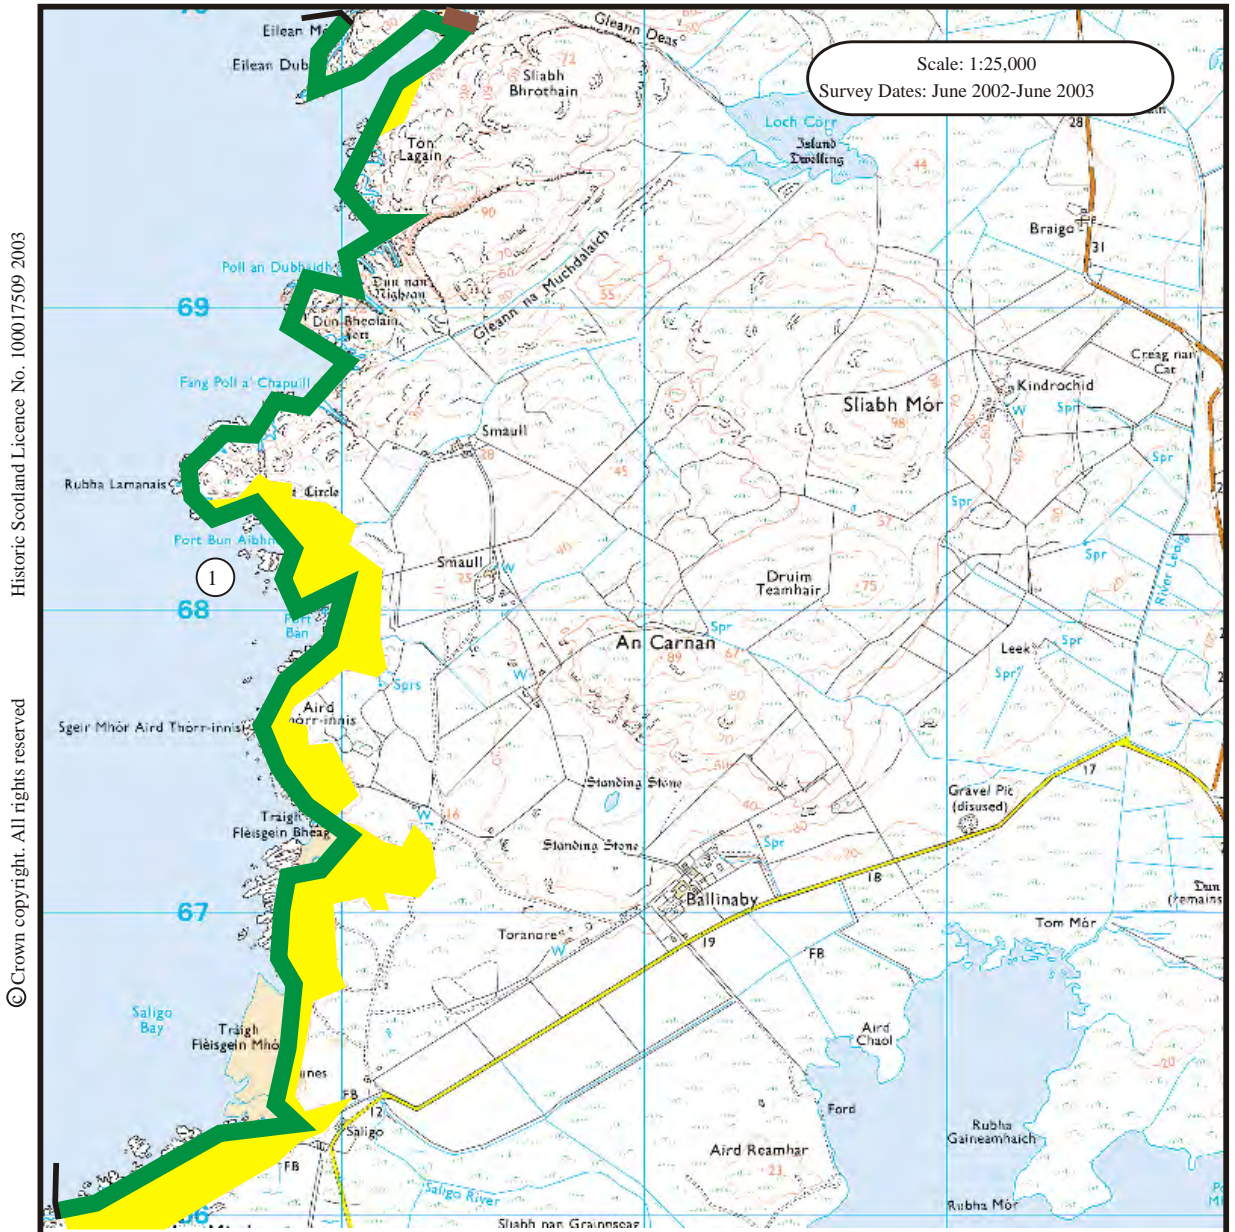
1. Smaull

Stable

The coast edge in this unit is rocky and stable. No signs of erosion on the coast edge however there is erosion behind Traigh Bhan. The erosion is on the sides of a stream which cuts through gravel deposits; it may be caused by animal disturbance.
