## **Introduction to Map 30: Sgeir Alt Mhic Eoghainn to Ton Loisgte**

Built Heritage & Archaeology

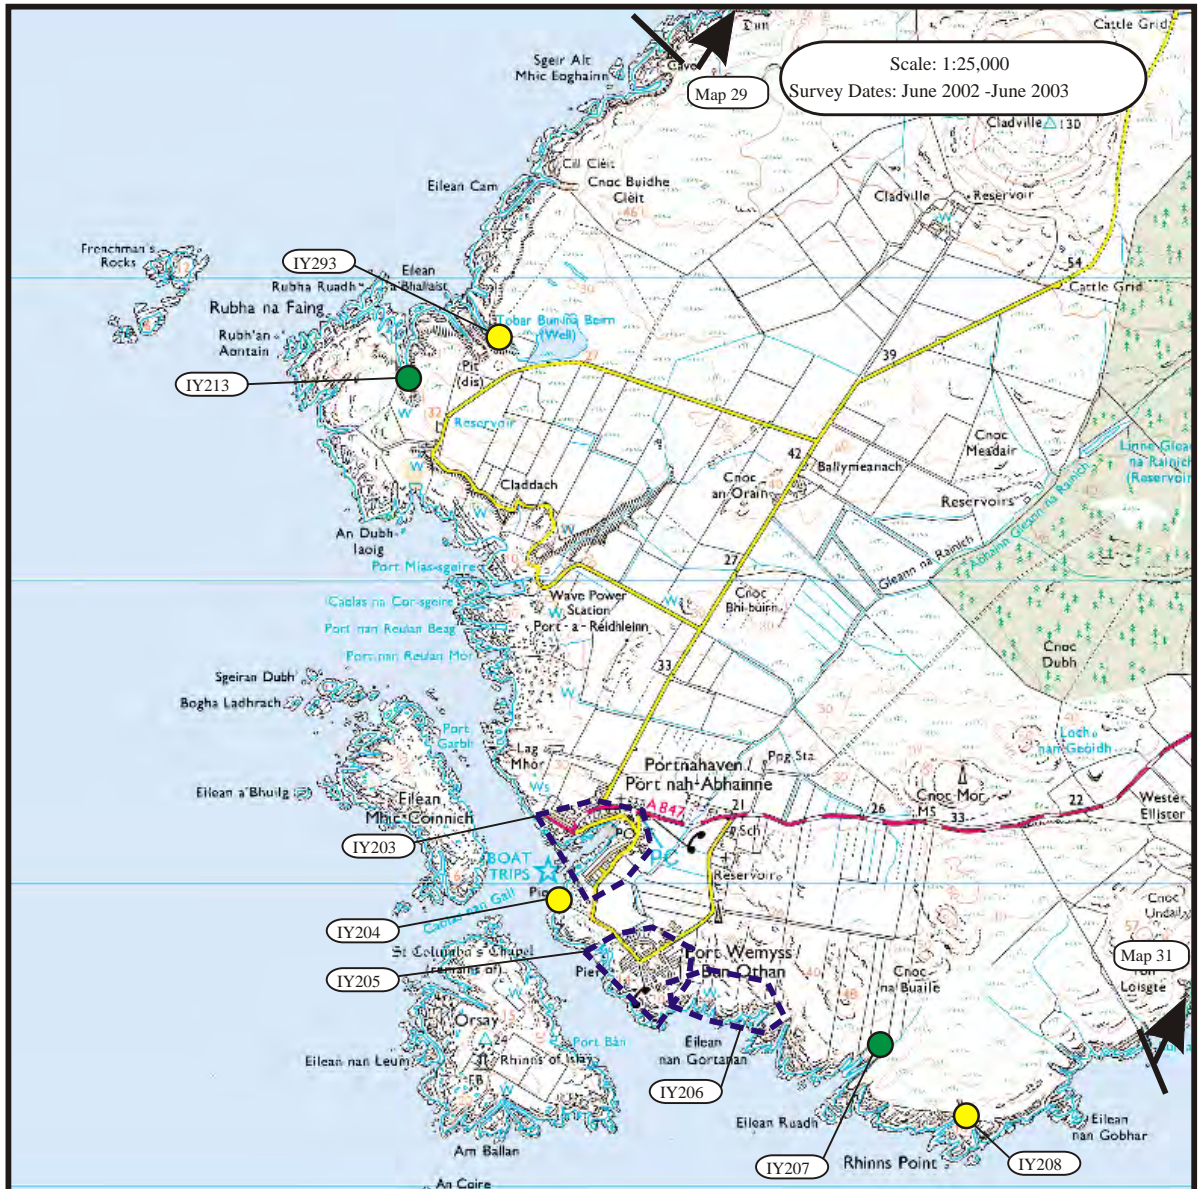
A total of eight sites were identified within this map section; five of these had been recorded previously. The majority of the sites are of 18th -20th C date. They include Portnahaven (IY203) and Port Wemyss (IY205) settlements and their piers (IY204), a boat noost (IY213) and cultivations (IY206). Portnahaven began as a poor fishing hamlet, in the mid-late 19th C the present village was designed and built, together with the planned village of Port Wemyss, under the encouragement of Captain Walter Campbell of Sunderland. Built on steep slopes surrounding the harbour, the houses comprise of both single storied and lofted cottages with slate roofs; many have been modernised in more recent times. Port Wemyss, also a fishing village, lies to the south east of Portnahaven and has terraced houses built on high ground overlooking the small port. The houses are mainly single storied and were set out with strips of garden ground. There is a jetty and a pier and several landing places for boats on the rocky coast below the village.

Of uncertain date are a dun at Rhinn's Point (IY208), clearance cairns (IY207) and stray finds of flint from close to the shore at Claddach (IY293). The dun sits on a sheer rock which is surrounded on all sides by the sea and is now inaccessible. There are signs of banks, the most visible of which lies on the landward side. The summit of the rock is undulating and has a hollow which may indicate the presence of structural remains.

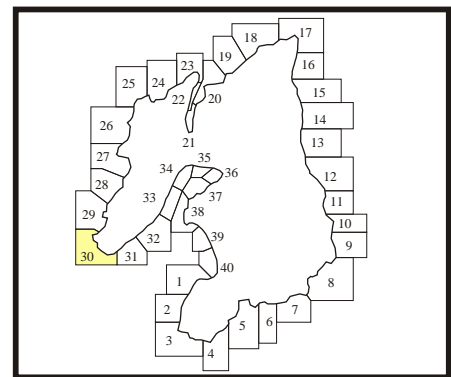
**1. Portnahaven**

Rock platform

Coast edge mostly <5m

Drift on visible rock/ Raised beach etc.

A rocky coast edge with cobble cover, and some sand in coves. There are large areas of raised beach behind the coast edge at Claddach and south of Cnoc Buidhe Cleit.

The hinterland is poorly drained rough grazing, except at Portnahaven, which is built on. The coast edge is protected by sea walling in Portnahaven.

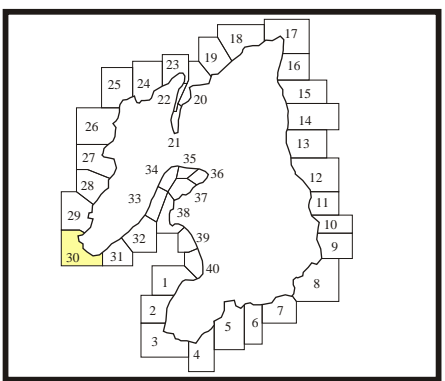
**1. Portnahaven**

Stable

The coast edge in this unit is rocky and stable. No signs of erosion.
