Introduction to Map 4: Alt an Daimh to Port an Eas

This map section covers some 5.8km of coastline. This area takes in part of the south eastern side of the Oa Peninsula. From the 100m high rocky cliffs which form the southernmost tip of the peninsula, the land gradually lowers in height down towards the eastern side to a rocky coastline no more than 50m high. The hinterland here comprises a higher proportion of grazing land than moorland. There is no modern settlement within the coastal zone and access to the coast is by way of tracks leading from the interior to Stremnishmore and Ballychatrigan farms. The coast edge here has been classified as stable.

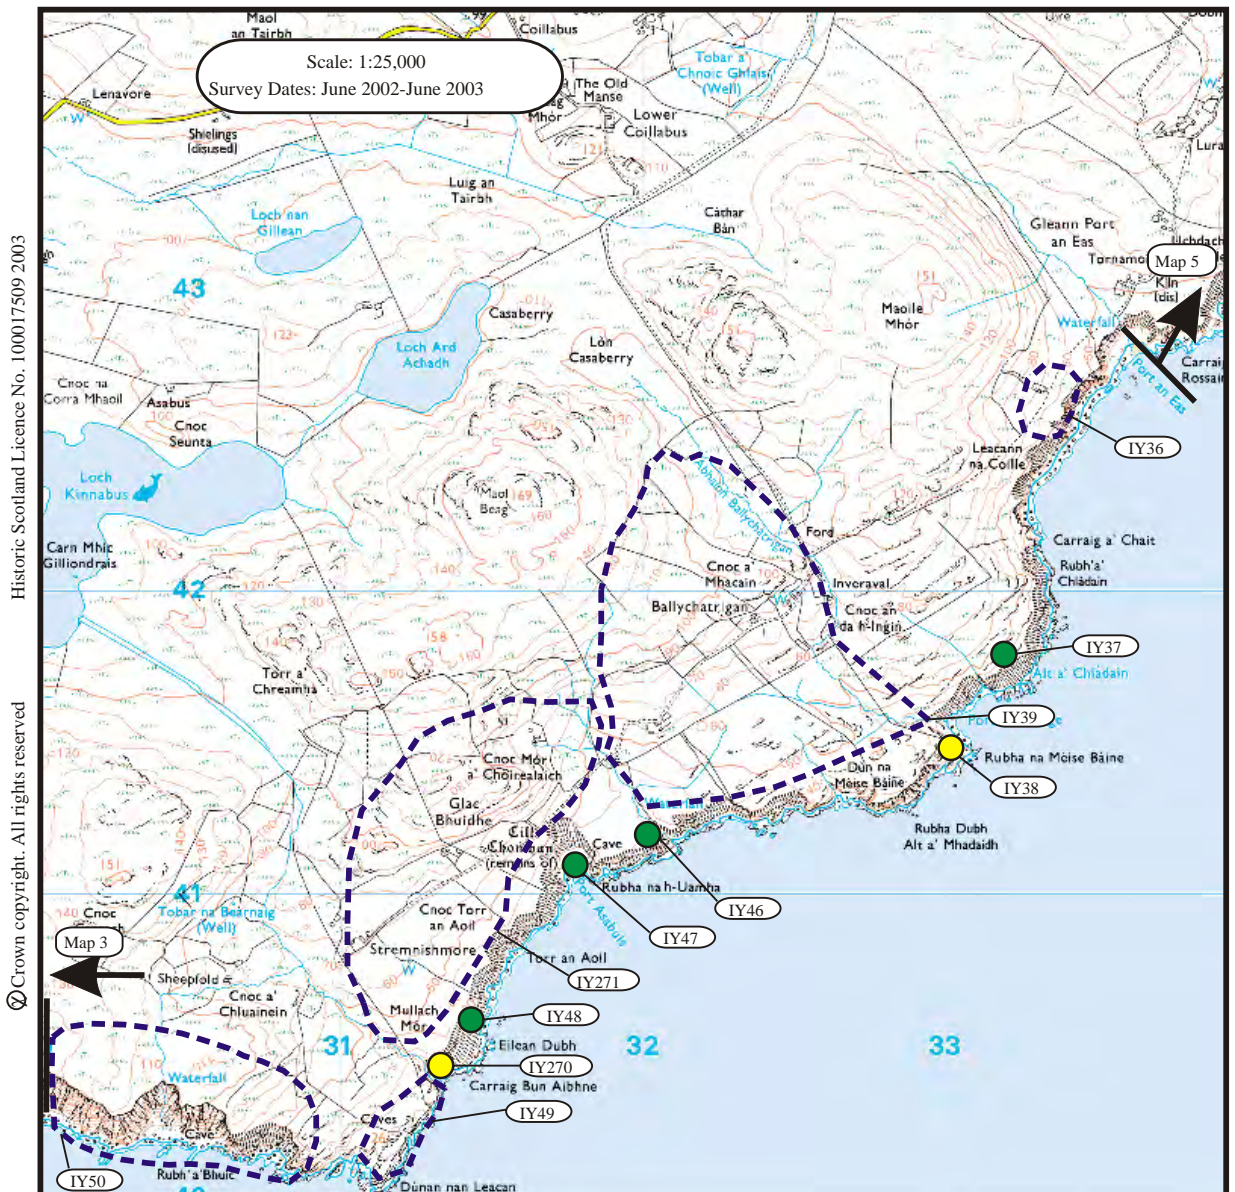
A total of eleven sites were identified within this map section; six of these had been recorded previously. The majority of the sites, seven in all, are thought to be of 18-20th C date. These include field systems and cultivation remains and a slipway. These remains cluster around the farmsteads of Stremnishmore and Ballychatrigan.

Four sites could not be dated from their topographical remains alone. These include two previously recorded dun sites at Carraig Bun Aibhne (IY270) and Rubha Na Meise Baine (IY38). The former is an alleged dun situated on the irregular summit of the elongated rock stack and was not inspected during this survey. The latter is located on an outcrop surrounded by the sea on three sides with access via a narrow causeway which has been artificially shaped to form a rough stair. A wall runs across the approach and extends around the lip of the bowl-shaped interior.

The remaining undated sites are a subrectangular structure (IY46) and a group of cairns (IY37). The rectangular structure sits on a platform and is aligned east-west, allowing for the possibility that it may be a church. The cairns may be the result of clearance, although no trace of cultivation or field boundaries was noted in the surrounding area and the possibility that they may be burial mounds cannot, on present evidence, be discounted. It is recommended that this site should be surveyed and that the dun at Rubha Na Meise Baine (IY38) and the putative church structure (IY46) be monitored for future changes.

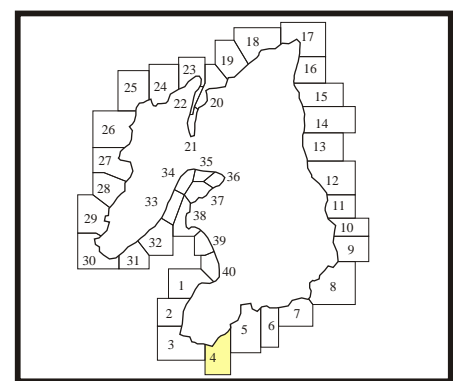
1. Ballychatrigan

Rock platform

Coast edge >5m

Drift on visible rock/ Raised beach etc.

The coast edge in this unit is generally high - on average 30m. The cliffs occasionally move away from the coast edge to leave flatter areas above the high water mark, interpreted as raised beach. Here, there is cobble cover on the foreshore. The hinterland is poorly drained rough grazing.

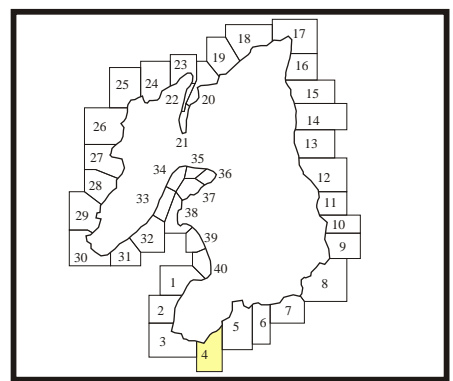
1. Ballychatrigan

Stable

The coast edge in this unit is rocky and stable. No signs of erosion.
