MAP 34: MULLOCK BAY TO PORT MARY

Map 34: Hinterland Geology and Coastal Geomorphology

MAP CLASS: Hinterland Geology and Foreshore Geomorphology

Assessment date: November 1996

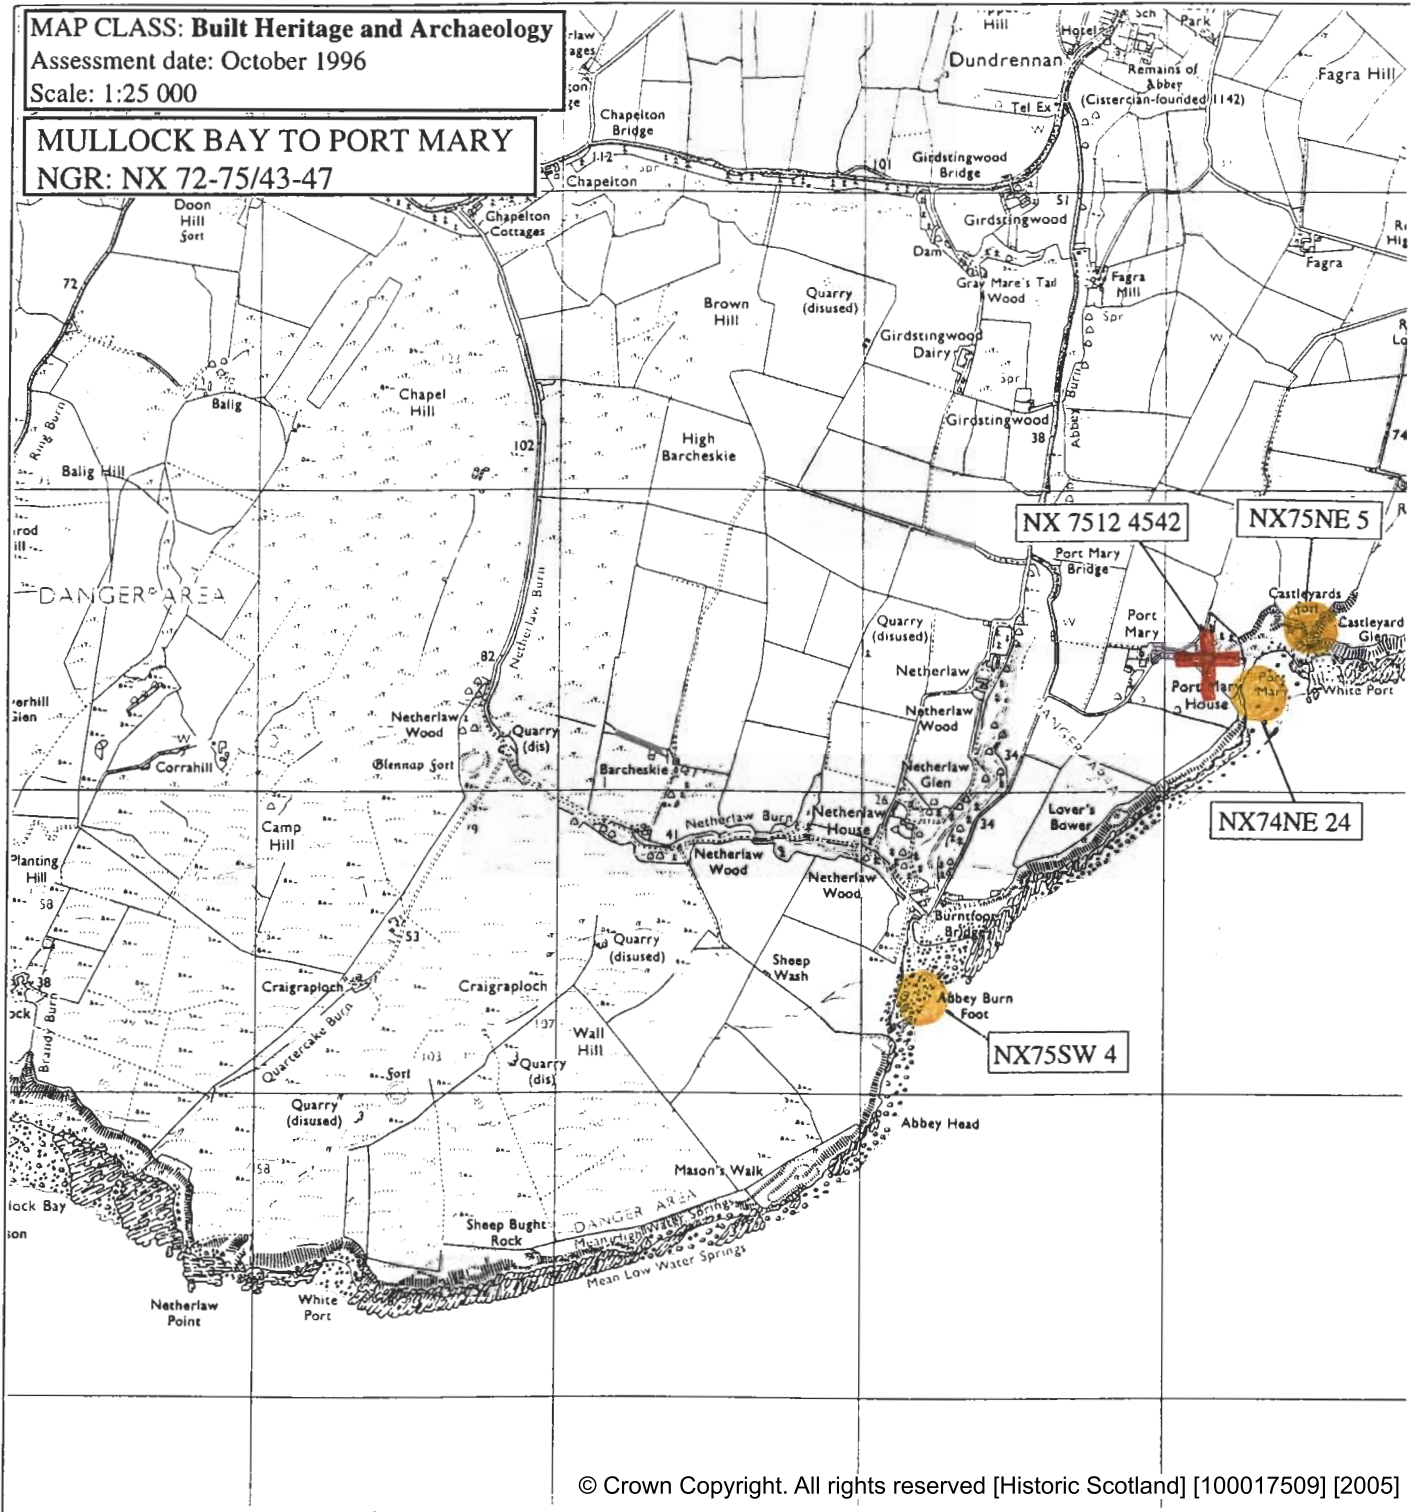
34: BUILT HERITAGE AND ARCHAEOLOGY

NX74SW 4
NX 742 443
ABBAY BURN FOOT
Natural Harbour
Uncertain
Good
Nil

NX74NE 24
NX 753 453
PORT MARY
Landing Place
Uncertain
Uncertain; not located
Nil

NX 7512 4542
PORT MARY HOUSE
House
Statutory Listed Building
Late 18th century
Good
Nil

NX75NE 5
NX 7548 4552
CASTLEYARDS
Promontory Fort
1st Mill BC/AD
Good
Nil

Built Heritage & Archaeology: The archaeology of this section of the coast is dominated by the small cluster of monuments at Port Mary, comprising a natural landing place, on the coastal edge, and a promontory fort and listed building in the immediate hinterland. Coastal erosion does not affect any of the sites. Of much greater significance to the condition of the promontory fort of Castleyards is the occurrence of a pit containing dead sheep and calves immediately within the interior of the rampart. A survey and monitoring programme is strongly recommended.
