Map Introduction: South Uist Map 9

This map section covers part of the northwest coast of South Uist. It extends from Drimsdale to Geirinis. There is modern settlement within this area, but it lies behind the coast, clustering around Stadhlairgearraidh and Geirinis. A rocket range occupies much of the coastal hinterland. This area is largely unenclosed and is also used for sheep and cattle grazing.

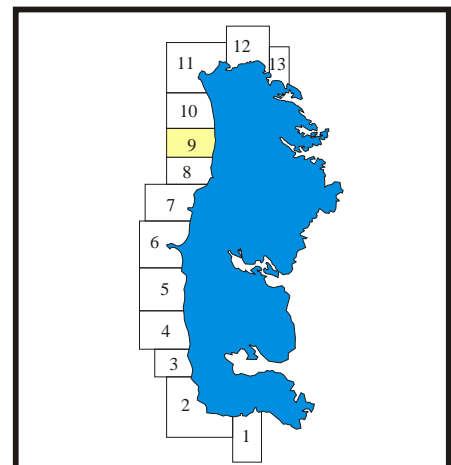
1. Sgeir Dhreumasdail to Loch Cille

NF 749365 to NF 754417

3.75 km

Mainly Sand

Coast edge >5m

Blown sand

Low clifflines of dunes and machair are developed along this section. In general the southern section of this dune line is fronted by accumulations of beach shingle. The northern section, by contrast, is fronted by beach sands.

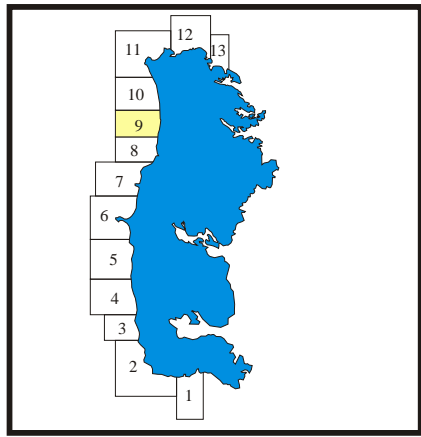
1. Sgeir Dhreumasdail to Loch Cille

NF 749365 to NF 754417

3.70 km.

Eroding

The southern section of this coastal section is typified by a 2-4 m high vertical cliff eroded in coastal dunes while the cliff base is locally obscured by shingle. Farther north between NF 754395 and NF 754404 the cliffline is stable while farther north between NF 754404 and NF 754409 the cliffline is accreting. Even farther north, between NF754412 and NF 754415 at a military installation, the coastal edge is protected by a line of gabion baskets that have remained largely undamaged during the recent hurricane. An exception to this pattern occurs at the northern extremity of this gabion line where damage is evident.
